## Why did the master in parallel-packs system suffer seriously under-voltage?

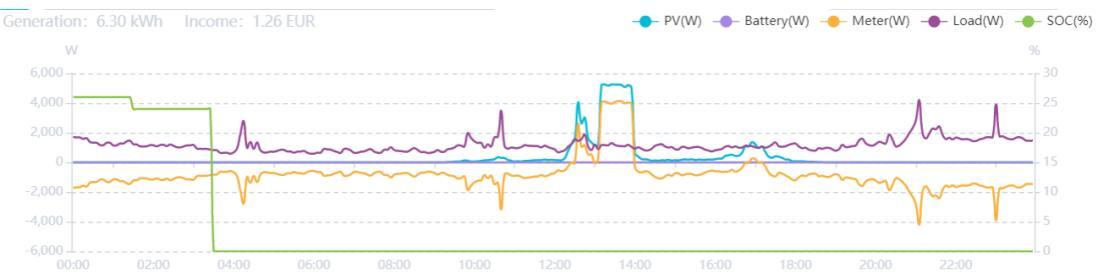
Question: A 4 packs in parallel system, battery SOC dropped from 24% to ZERO suddenly.
10 days later, the master battery was found seriously over-discharged and the voltage was only 6.14V, while the rest 3 packs' voltages were about 44V. Why?

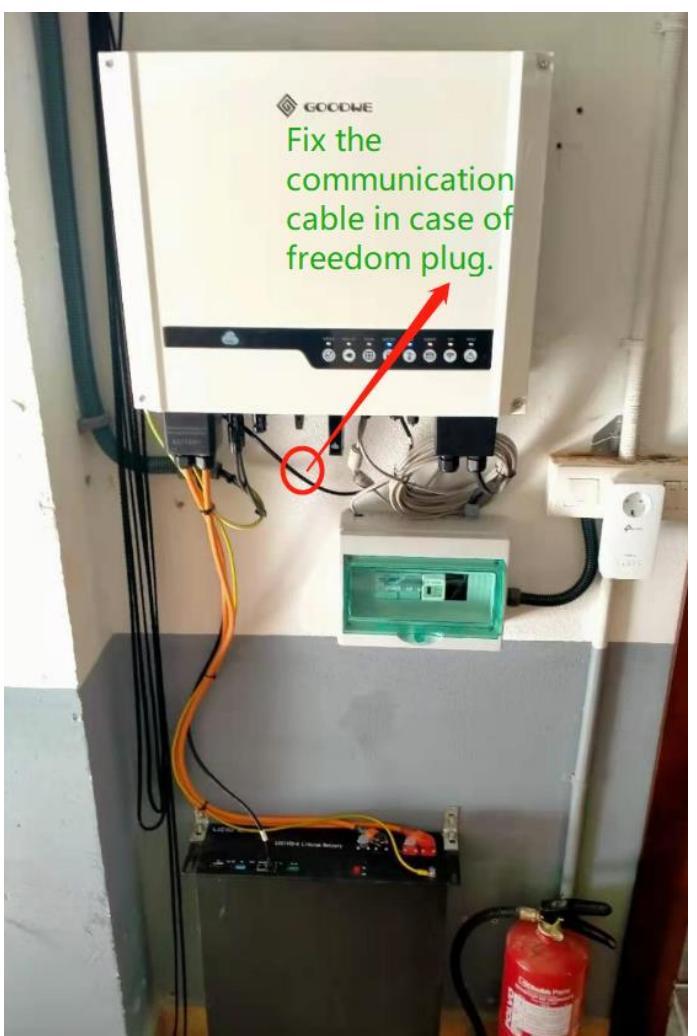
Firstly, the loss of communication between the battery and the inverter is the main reason. If the communication cable is freely plugged into the inverter, the connection is easily to be loose. Thus the communication is lost, and it is recommended to **fix the inverter side of the communication cable in case of freedom plug.**

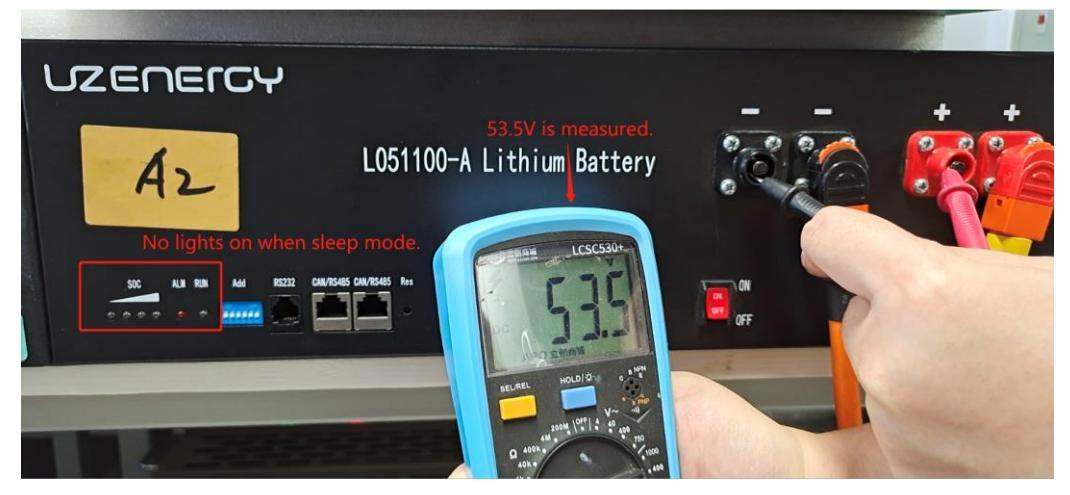
[1] When battery enters sleep mode, the discharge mos is still closed and a normal output voltage is measured.

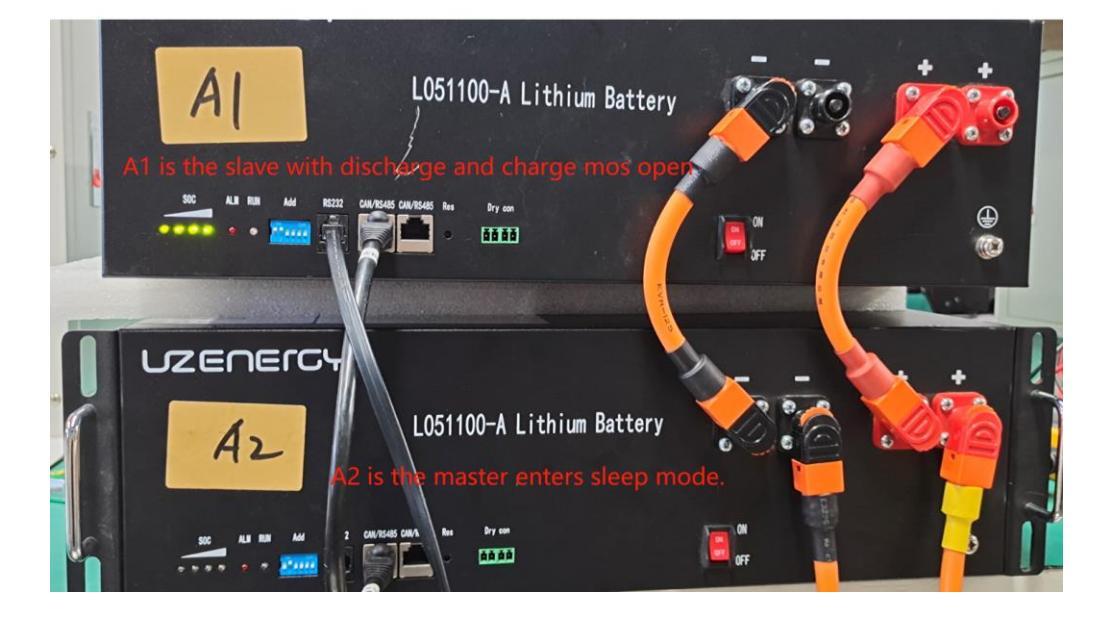
[2] When the master enters sleep mode, the slave stops discharging and charging.

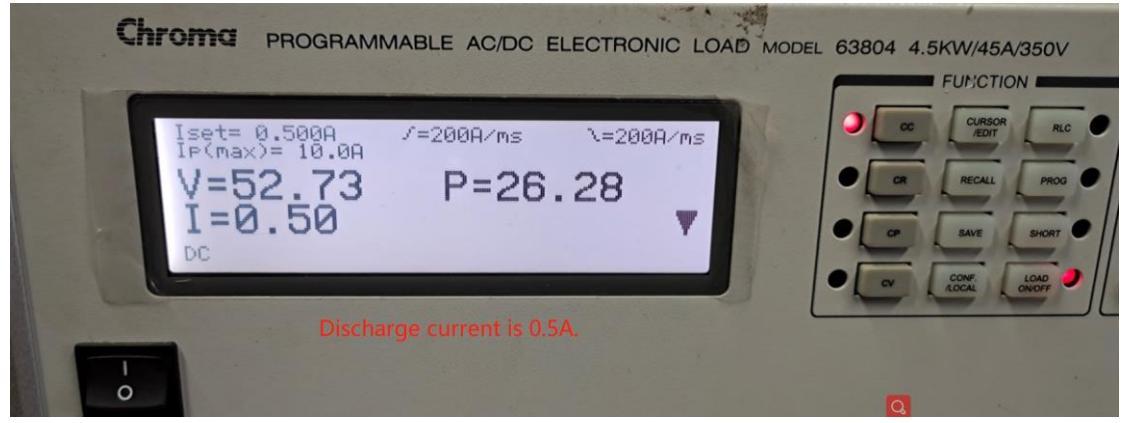
[3] The master discharges with a current of 0.5A, and this current is too small to be measured by BMS, so that the master would not be woke up. The master keeps discharging without a stop even when under-voltage-protect.

inverter is lost. As we know, when pack voltage is under 48V or cell voltage is under 2.8V, meanwhile, no current, then the battery will enter sleep mode. So, in this case, the master entered sleep mode before it discharged to under-voltage-protect. Then the communication between batteries lost and the rest pack stopped discharging and charging. As the discharge mos was still on and the discharge current was less than 1A which could not be measured effectively by BMS, the master battery could not be waken up and disconnect discharge mos when under-voltage-protect, it just kept discharging and suffered seriously under-voltage. **To solve this problem, the discharge mos open in sleep mode would be updated in our new BMS firmware.**
